Re: Sanitary Survey Inspection of Meadow Hills Water and Sewer District PWS
(PWSID: MT0002925).

Meadow Hills Water and Sewer District (MT0002925)

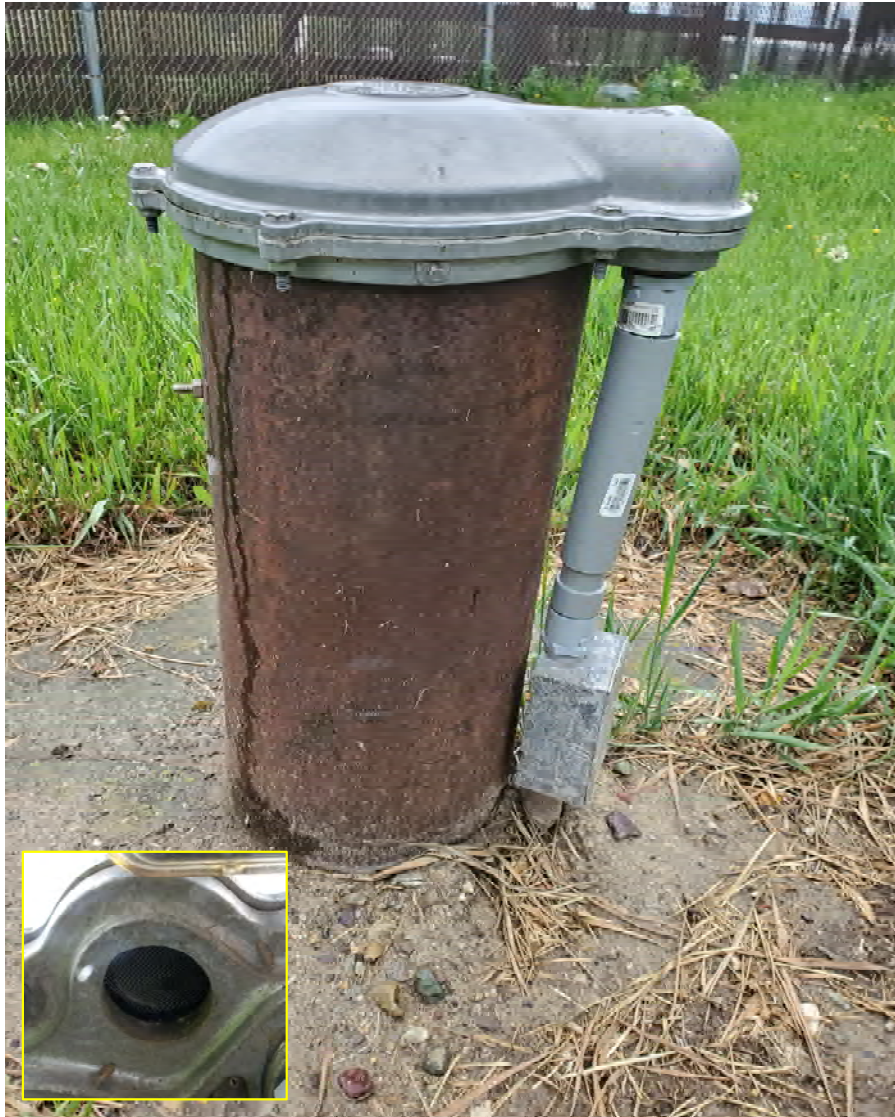
Well-1 (WL002): Well-1 is positioned between the pump house and the storage tank. It employs a turtle style wellhead cap which was secure, sealed, and properly vented (picture insert). The conduit servicing the well was also secure and free of defects.

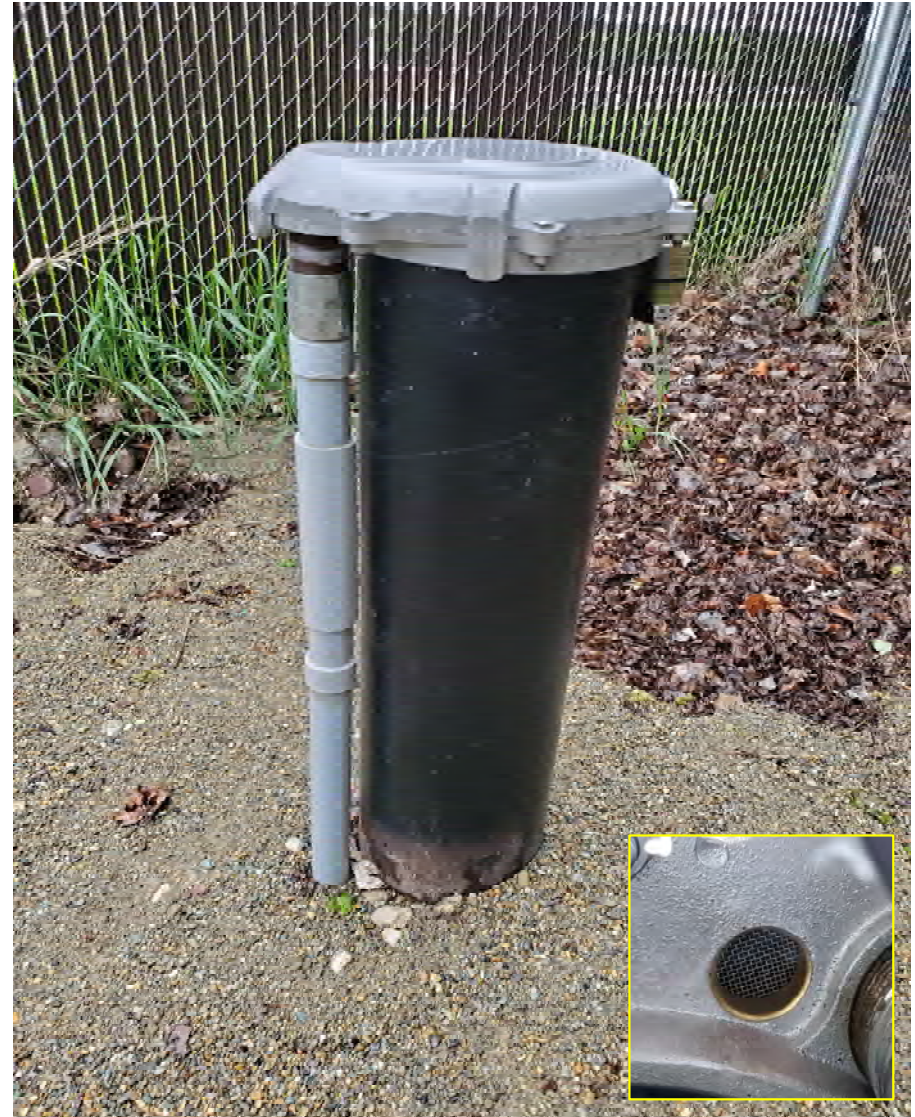
Well-2 (WL003): Well-2 is the new well which was installed in 2020. It is positioned off the NE corner of the Pump house. It also employs a turtle style wellhead cap which was secure, sealed, and properly vented (picture insert). The conduit servicing the well was also secure and free of defects.

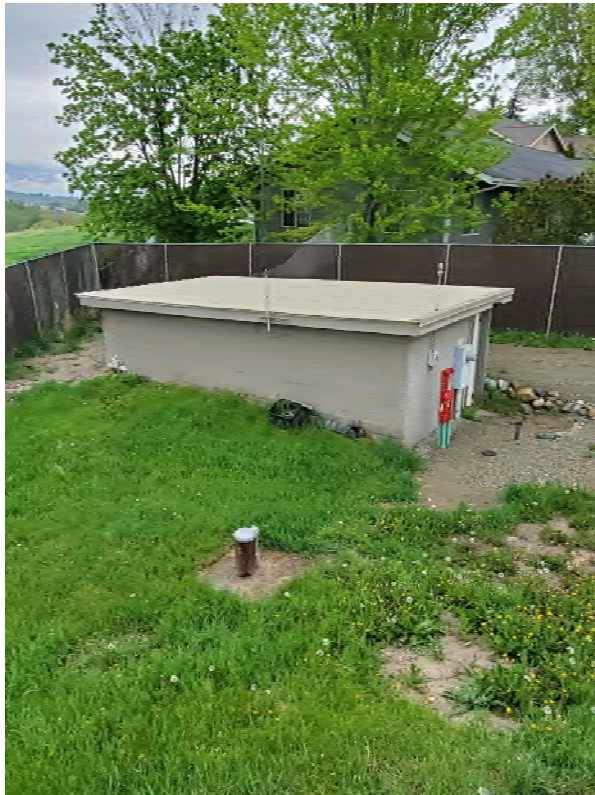
Top Left: Both wells, the Storage Tank (ST001), and the Pressure Control Assembly (PC001) are all located on a community lot (Lot-47) located behind the house at 355 Meadow Hills Drive. Well-1 is picture in the fore ground; Well-2 is behind the building.

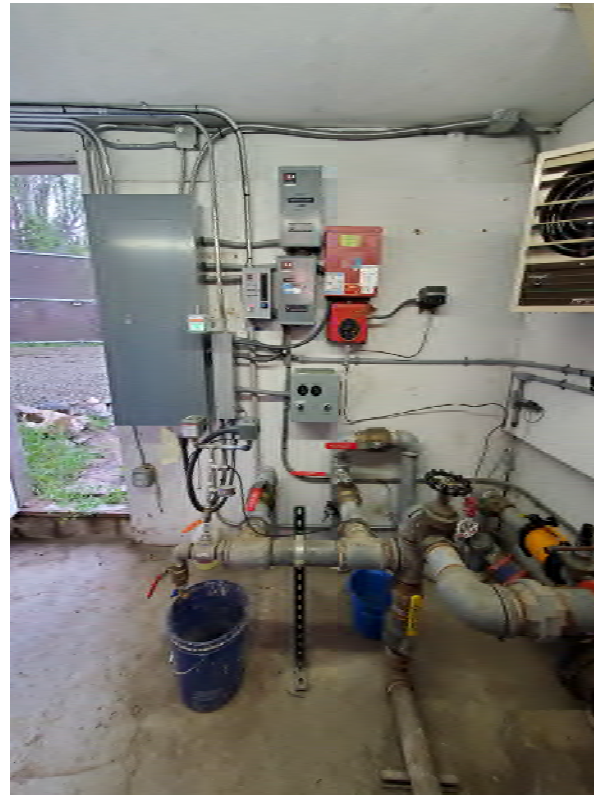
Top Center: Inside the building water from both wells join to a common header which fills the storage tank or can be bypassed to directly pressure the distribution system. Water from the storage tank is then pressurized using a 15hp and/or 10hp centrifugal booster pump(s). Two discrete pressure switches operate them in a lead/lag configuration.

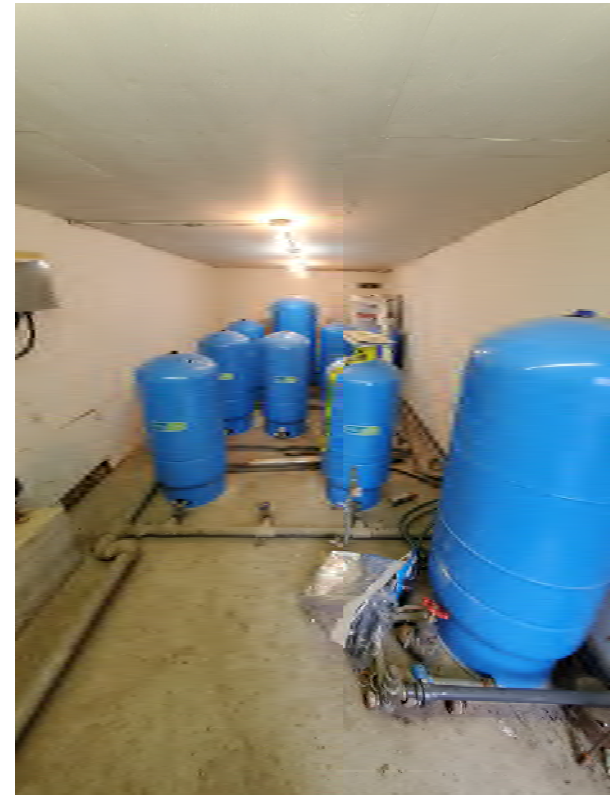
Top Right: Nine Captive air tanks float on the distribution header to provide back-pressure between pump cycles. It is recommended flushing the tanks on a regular basis to avoid water stagnation in the far tanks.

- It is recommended independently isolating and flushing the captive air tanks on a regular basis to avoid water stagnation in the far tanks. While each tank is drained during this process, the air pre-charge should be checked and set to 2-5psi below the pump “cut-in” (turn-on) pressure. This will provide optimal drawdown, reduce pump cycles, and generally give the pump and the captive air tank bladder a longer useful life.

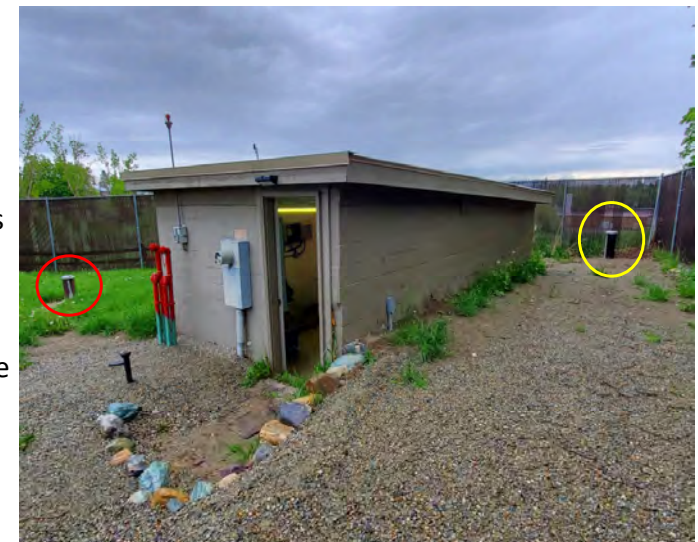
Bottom Right: Well-1 (red circle) and Well-2 (yellow circle) locations relative to the pump house.

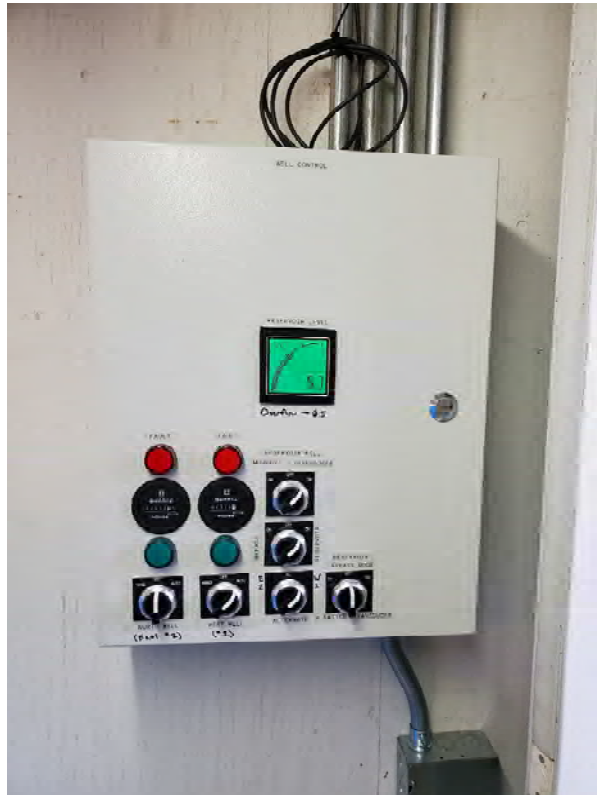
Top Left: As part of the system upgrades completed under EQ#22-2276 in August 2024, a new well pump control panel was installed to manage the storage tank water level and the operation of both wells. The new panel is capable of rotating or independently operating each well, operating the wells using the storage tank level or the pressure switches when the tank is bypassed, and maintain the storage water levels. This is a very functional and usable panel.

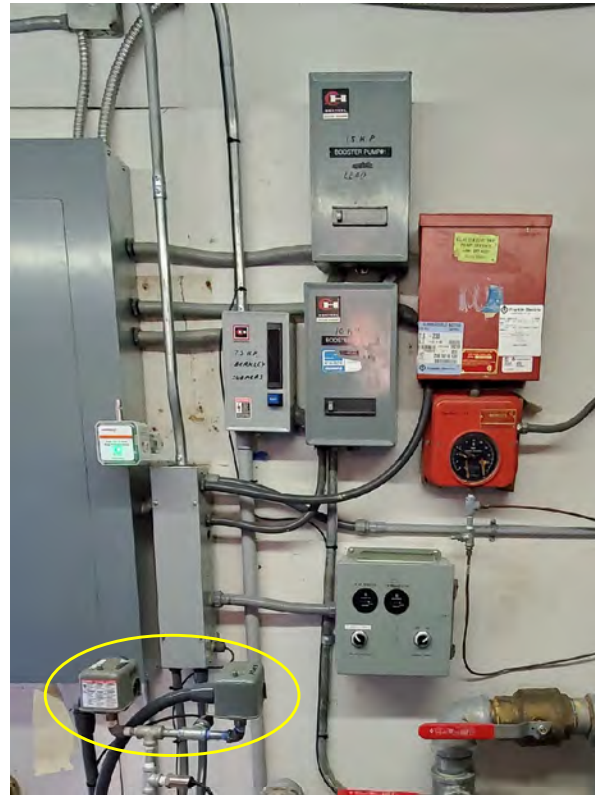
Top Center: The actual Pressure Control Assembly (PC001) consists of the 9 captive air tanks, a pressure gauge, a pressure relief valve, and two discrete pressure switches (yellow circle) to activate the 10hp and 15hp centrifugal booster pumps in a lead/lag configuration. The pressure window placed on the distribution system was observed to be 58-70psi during the inspection.

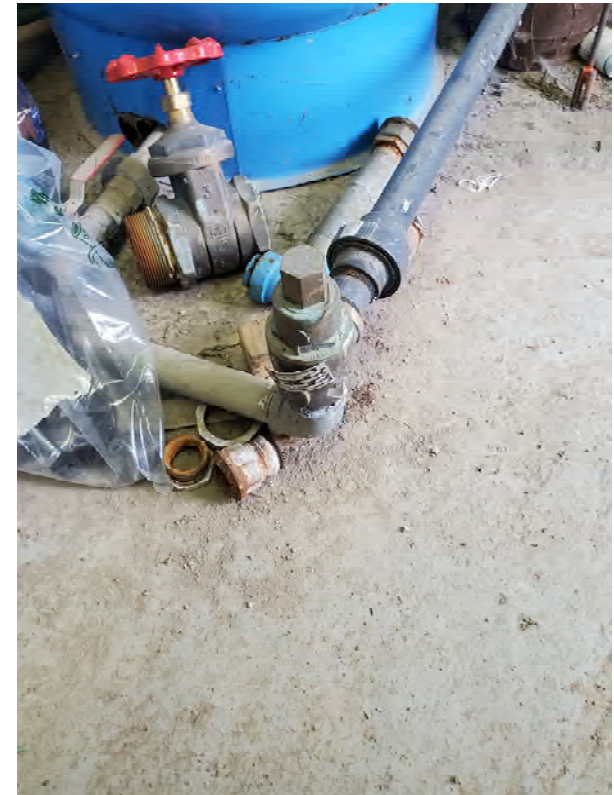
Top Right: The pressure relief valve was properly sized & plumbed to the exterior of the building.

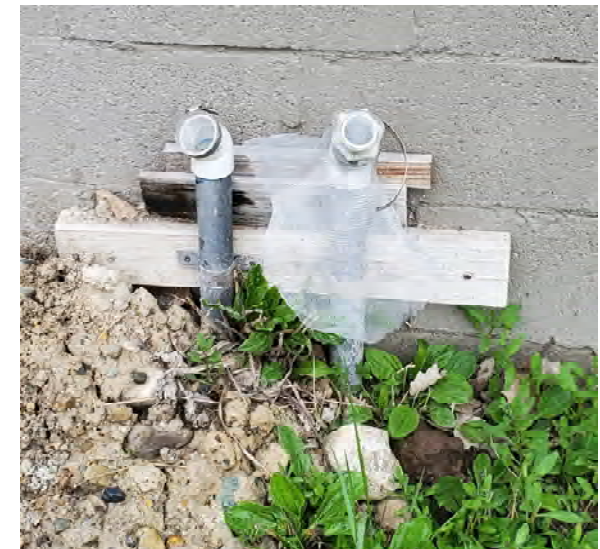
Bottom Right: The pressure relief valve and manifold flushing lines were both properly screeded on the exterior of the building.

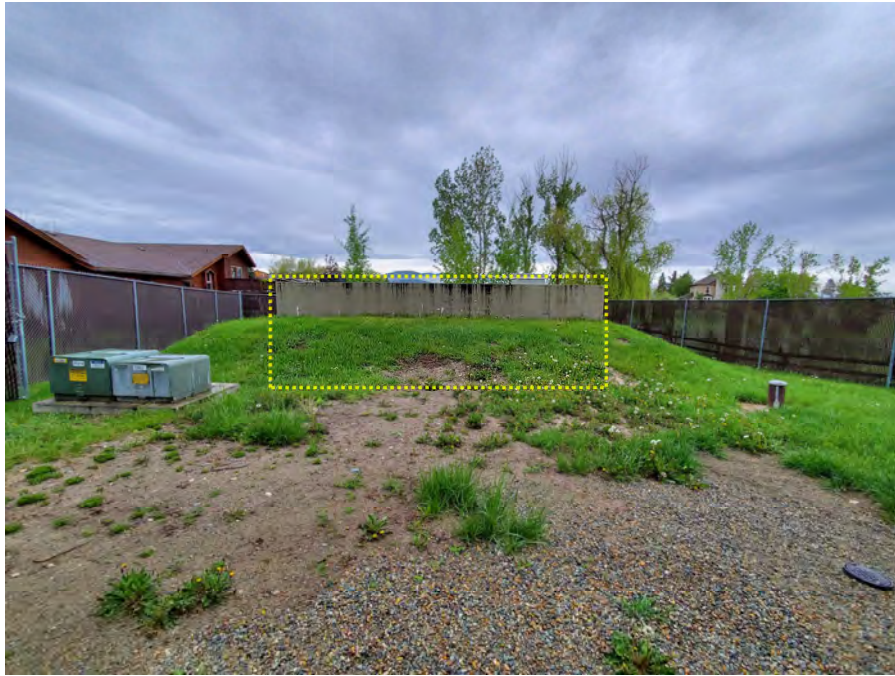
Top Left: The facility Storage Tank (ST001) is a 28,000-gallon partially buried cement and cinderblock storage tank. The tank was refurbished in the past by pouring new walls inside the tank but is beginning to show significant aging. Even for its age, the tank has been performing very well.

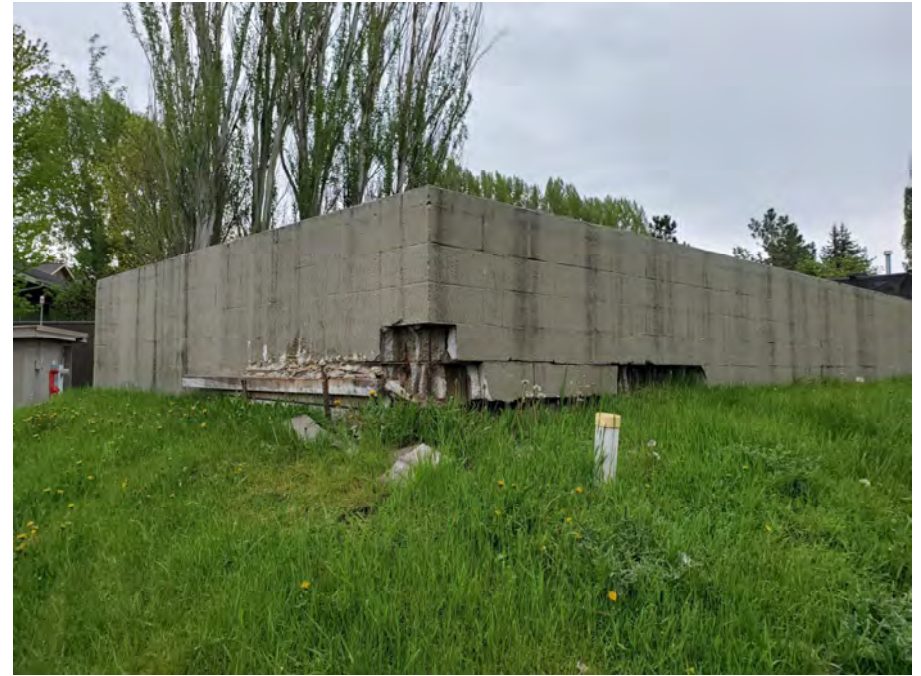
- The tank was refurbished in the past by pouring new walls inside the tank but is beginning to show significant aging. Even for its age, the tank has been performing very well. The outer cinder-block wall is degrading significantly on the back corner of the tank. It is recommended starting to consider replacing the storage tank during the next facility upgrade project. Since Meadow Hills has already formed a Water District, additional grants, funding, and low interest loans are available for replacing the tank. Please contact Mike Kropp (406-755-8791) at DEQ for more information on available funding.

Top Right: The outer cinder-block wall is degrading significantly on the back corner of the tank. It is recommended starting to consider replacing the storage tank during the next facility upgrade project. Since Meadow Hills has already formed a Water District, additional grants, funding, and low interest loans are available for replacing the tank. Please contact Mike Kropp (406-755-8791) at DEQ for more information on available funding.

- If a recommendation were to be made, it would be to start thinking about replacing the storage tank as the next system upgrade. As mentioned above, the formation of a water district gives Meadow Hills more access to grants, funding, and low-interest loans.

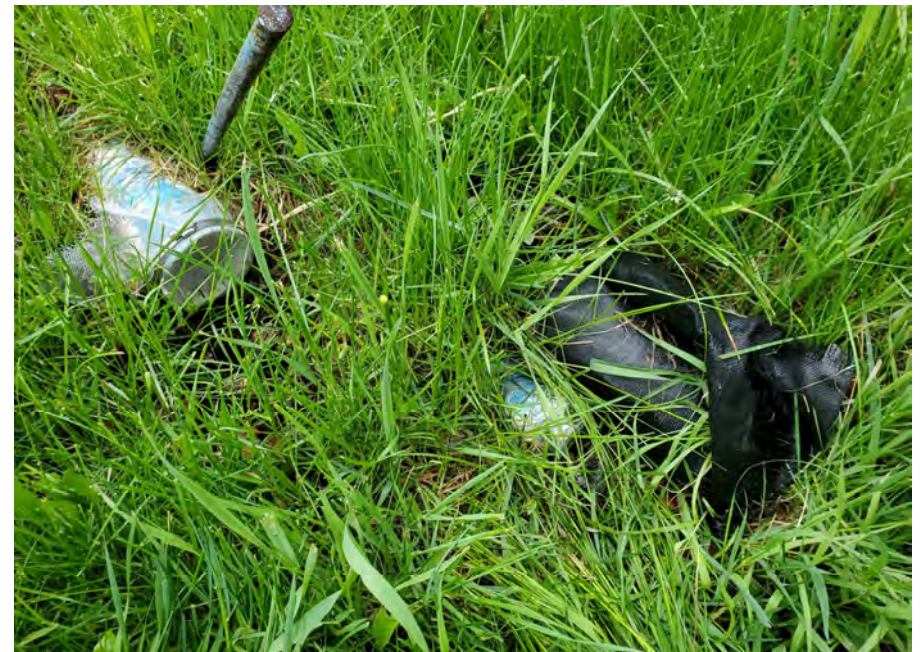
Bottom Right: The ST001 drain and overflow lines were properly screened at the northwest base of the tank.

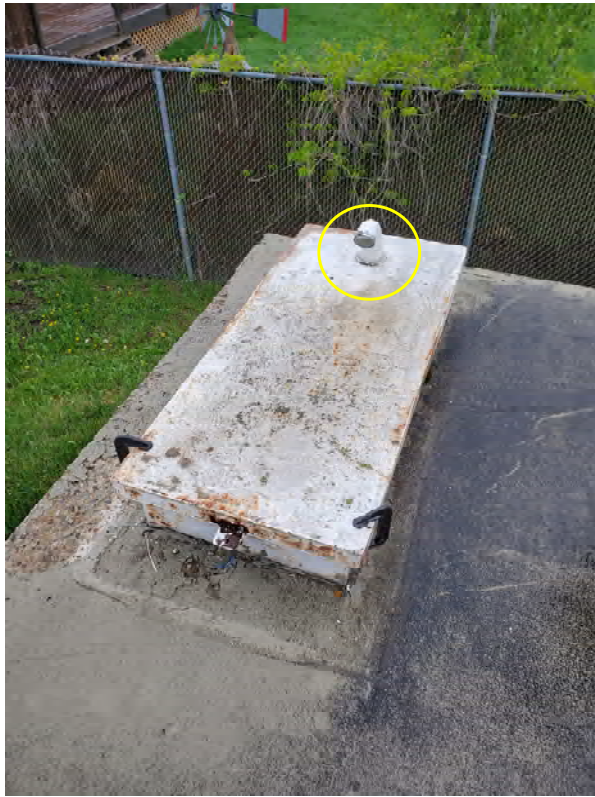
Top Left: ST001 has two access hatches on top of the tank to assist with maintenance activities. The older style hatch (pictured) is rarely opened with additional clamps to ensure a good seal on the tank. The ST001 tank vent (yellow circle) is installed in the hatch lid and was properly screened. Ideally this vent should face downward to avoid contamination from wind and rain.

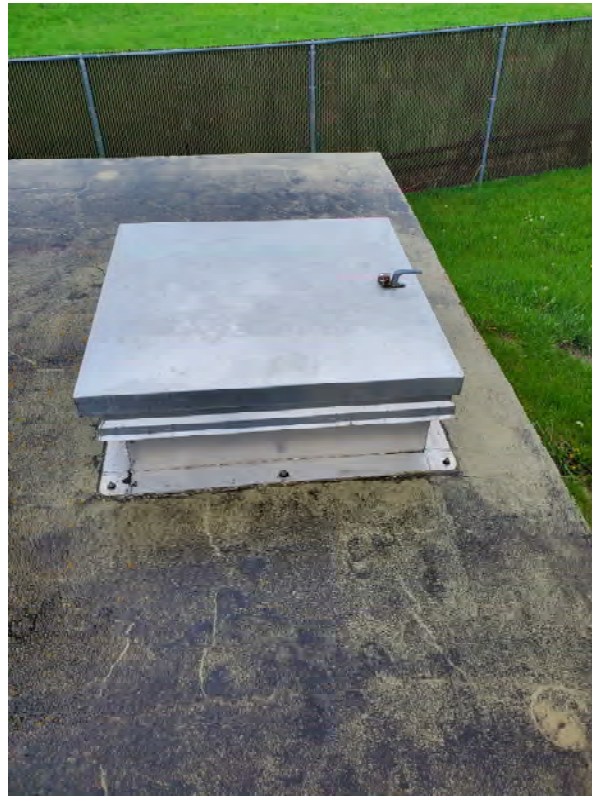
Top Center: The newer hatch is the primary access hatch for the tank. It consists of an aluminum hinged hatch that was secured with a pad lock for additional security.

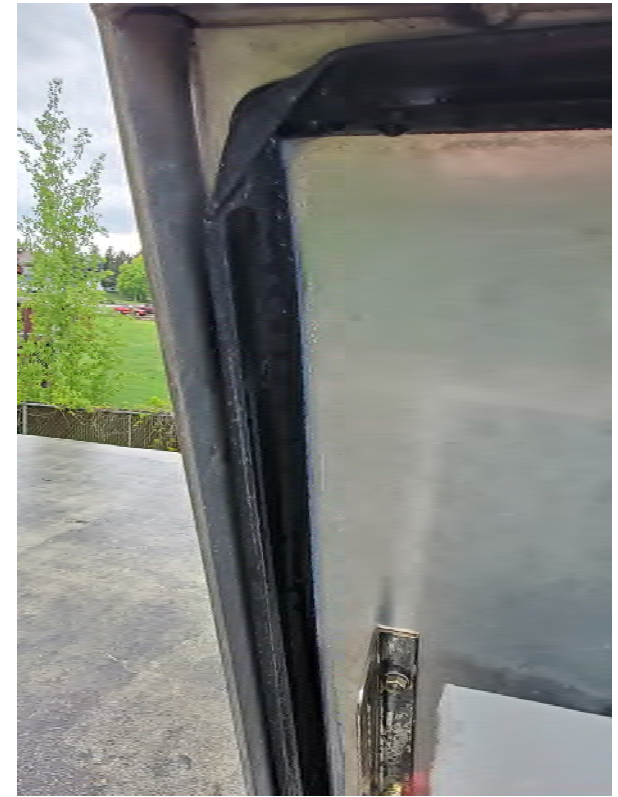
Top Right: The seals for the aluminum hatch lid were in great shape. No signs of insect activity were observed inside or underneath the hatch lid.

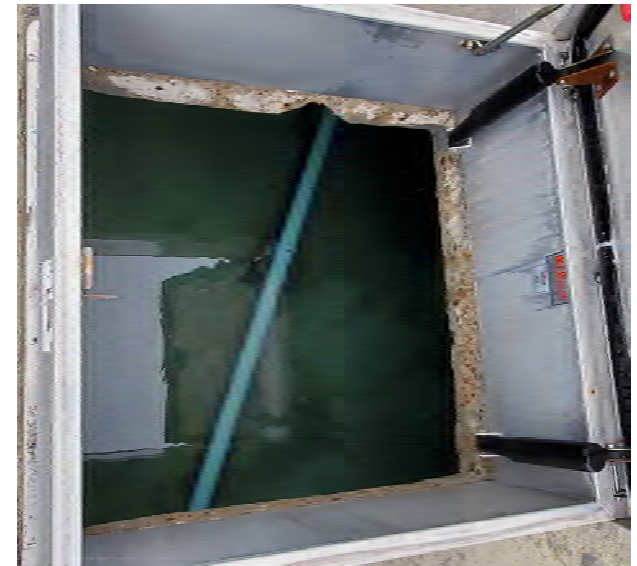
Bottom Right: The water inside the storage tank was clean, clear, with little to no sediment on the tank floor. The tank is cleaned and inspected on a regular interval which helps significantly with tank reliability.
