Re: Sanitary Survey Inspection of Meadow Hills Water and Sewer District PWS
(PWSID: MT0002925).

Meadow Hills Water and Sewer District (MT0002925)

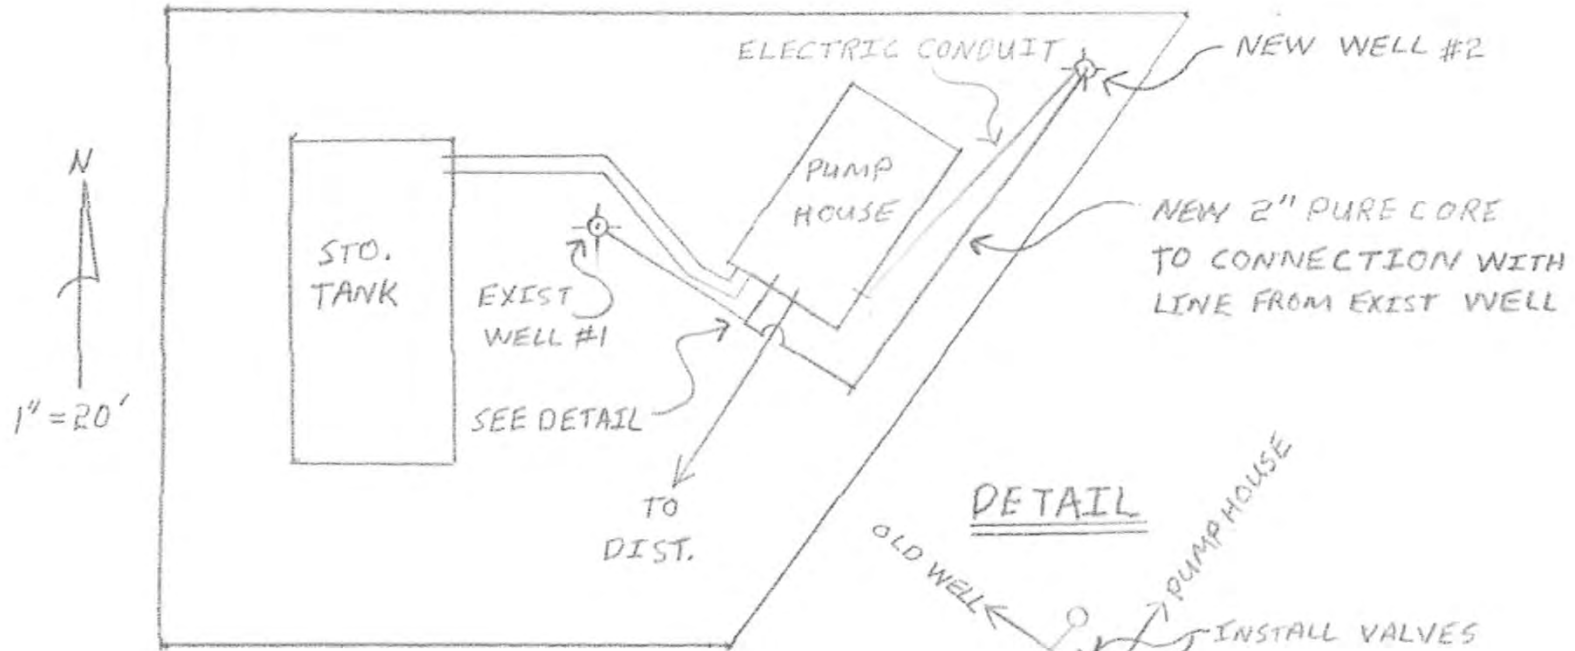
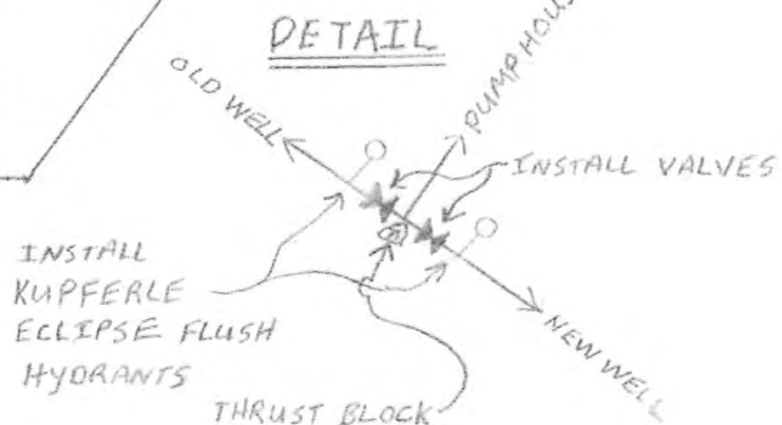
MEADOW HILLS UTILITY LOT LAYOUT, ADD REDUNDANT WELL AS BUILT, AUG 30, 2024

Notes: 9/6/24

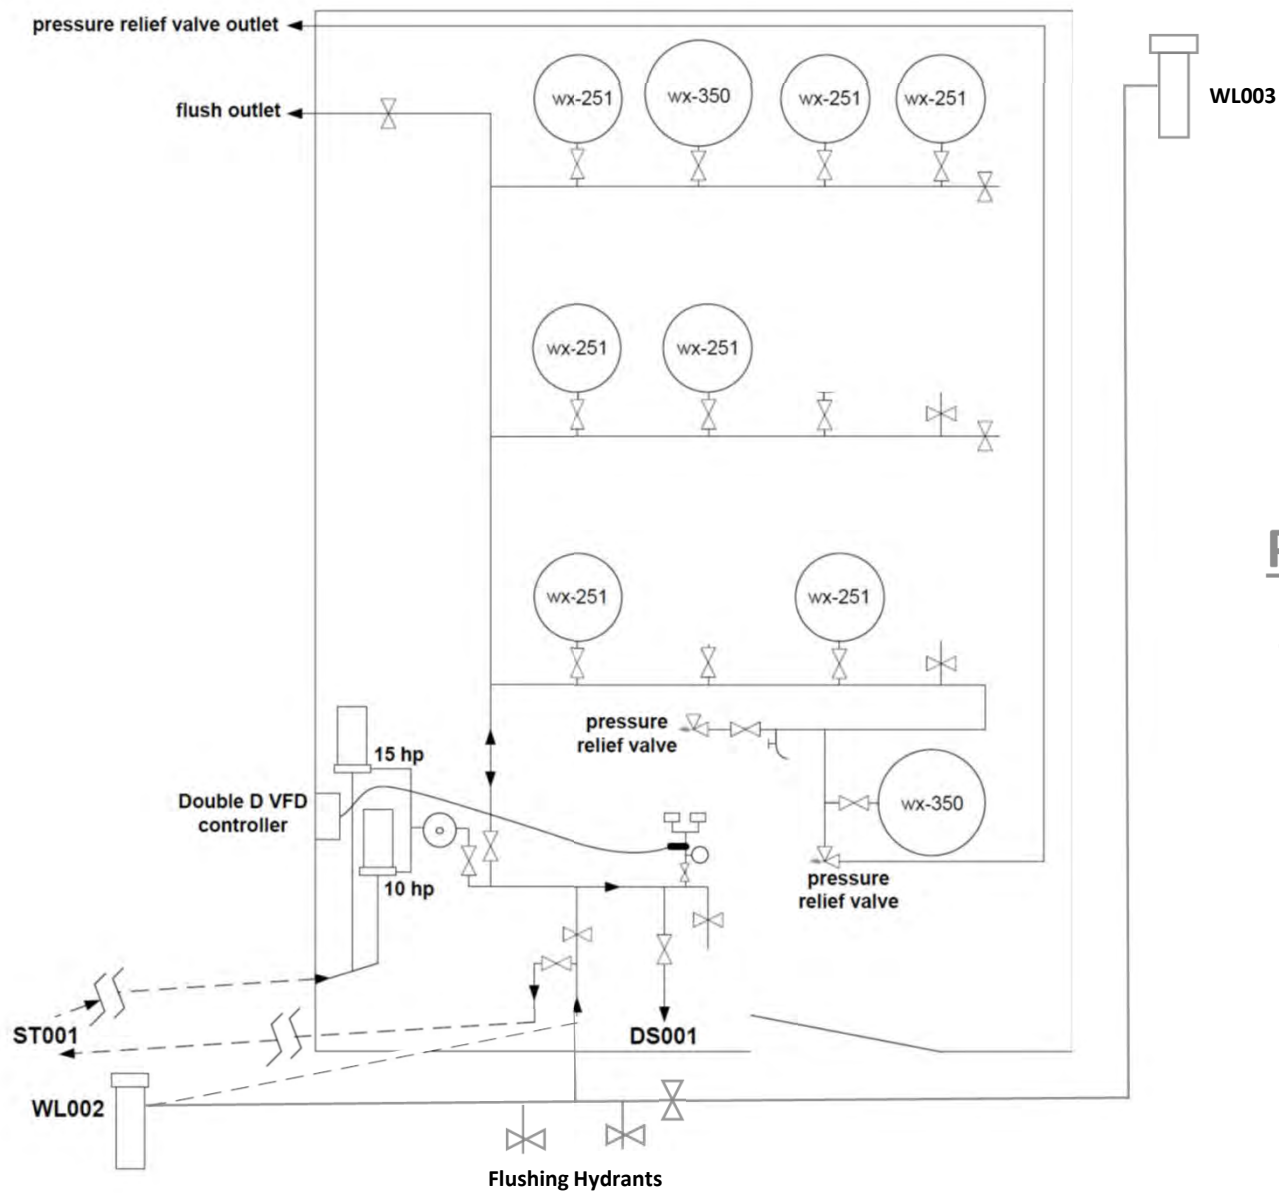
**Pump House &
Water System
Configuration**
(5/15/25)

Well-1 (WL002): Well-1 is positioned between the pump house and the storage tank. It employs a turtle style wellhead cap which was secure, sealed, and properly vented (picture insert). The conduit servicing the well was also secure and free of defects.

Well-2 (WL003): Well-2 is the new well which was installed in 2020. It is positioned off the NE corner of the Pump house. It also employs a turtle style wellhead cap which was secure, sealed, and properly vented (picture insert). The conduit servicing the well was also secure and free of defects.
